ENVIRONMENTAL HAZARDS AND SUSTAINABLE DEVELOPMENT OF ROCK QUARRIES, LOWER BENUE TROUGH NIGERIA

Abstract: The increasing number of abortive and abandoned quarry pits, and the several associated geo-environmental hazards have given cause for greater concern. Environmentalists, governments, and the general public now seek innovative ideas, and research collaborations that will reduce incidents of abortive and abandoned quarry pits. Quarry operators may be charged with the responsibility to reclaim quarry pits as soon as their operation is over, or make equivalent cost payment to government agency who will take over the responsibility as soon as mining is over. The goal is to achieve sustainable quarry practice in the Nigeria lower Benue Trough so that future generations may benefit from the igneous intrusive, and still have livable and sustainable environment

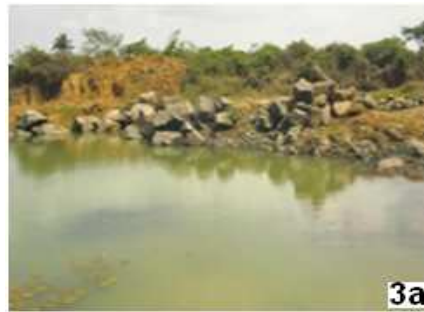
Figure 3a: Abortive quarry pit

Figure 3a is a large abortive trial quarry pit for over ten years. The pit area measures 100 m length, 85 m width, and 5 m average depth located within 500 m to community residential area. This pit was abandoned

following absence of massive and continuous intrusive body. Intrusive boulders were rather intercepted in spatial distribution that provided low and uneconomic overburden stripping ratio even at average depth of 20 ft from surface. There was no proper planning or design of the pit. This was traced to blind mining practiced by the operators. They could not conduct proper intrusive mapping, by applying suitable geophysical technique and/or use geologic method of coring. Community members interviewed confirm the pit as the largest mosquito and tsetse fly breeding ground in the neighborhood. They complained of persistent malaria and sleeping sickness, both of which they claim has inflicted laziness and poverty to their people. Some of the community members lamented over the number of domestic animals that have drowned in the pit. They demanded emergency response by government towards fencing off the pit, pending when reclamation activity could commence. At the time of this study, the quarry operators have left the site for over 15 years, leaving behind some of their unserviceable tools.

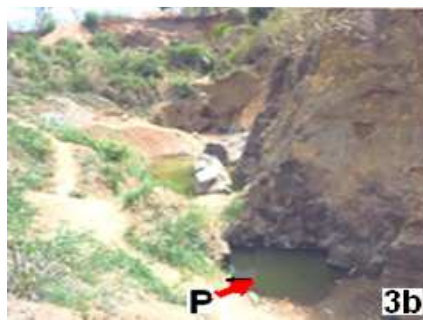
Figure 3a: Abandoned trial pit, no pit design.

Figure 3b unlike 3a is not a full established quarry; it is produced by a more local mining method based on continuous trial excavation and selection of boulders, followed by hand breaking of the boulders. These activities have been on in this area for over thirty years. This has resulted in deep excavation pits exceeding 50 ft at some points. In order to disintegrate a boulder, the miners pour used engine oil over the boulder, to penetrate any cracks and joint planes. They cover same with wood, and set fire on the set-up. The set-up is allowed to burn over a night, until the oil is burnt out. This process weakens the boulder which now responds to disintegration by sledge hammer blows. The use of oil and burning respectively are not environmentally friendly. The stagnant pool of water marked as *P*, provide perennial source of domestic water to the local miners. This site experiences frequent rock fall, often causing injury and death to the operators, and domestic animals.

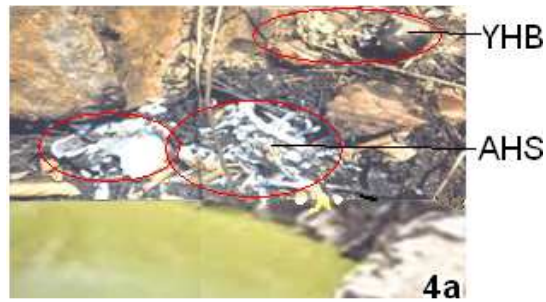
Figure 4a: Exposed adult human skeleton (AHS) and a decomposing young human body (YHB).

their reclamations by the operators or the law. Reclamation practices, such as using recovered earth materials and re-vegetation, and employing mitigation measures to offset potential impacts to lives, properties, domestic animals and wildlife is necessary. Dead human bodies, dead wild and domestic animals, as well as skeletons may be found within and around such pits even when isolated from residential areas. Figure 4a shows a complete adult human skeleton (AHS), and a decomposing body of a child of about ten years (YHS) littered at the shallower part of a blind mining trial pit. This was observed because water in the shallower part of the pit dries up during peak of dry season (December-to February) when this investigation was conducted.

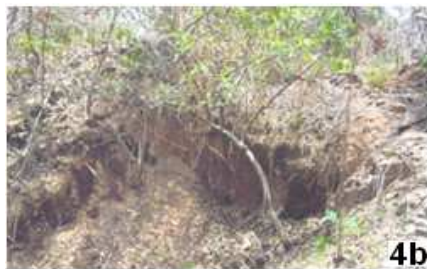
Figure 4b: Pit overburden sliding and rock fall.

Blind mining trial excavation pits usually have no design of slope, bench height and haulage. Figure 4b; A trial pit overburden material becomes weak due to continuous blasting and excavation. The overburden hanging wall becomes increasingly weak during the peak of rain season (May-August) when surface and subsurface water movement saturate the overburden. As a result, the hanging walls of the overburden continuously get weaker and unstable. Abandoned quarry pit slope instability and increasing weakness of overburden wall causes geo-environmental hazards. There is danger to movement of man and other organisms and unquantifiable threat to ecosystem as long as these pits remain open and unprotected. Major geo-environmental hazards include rock fall and overburden sliding.

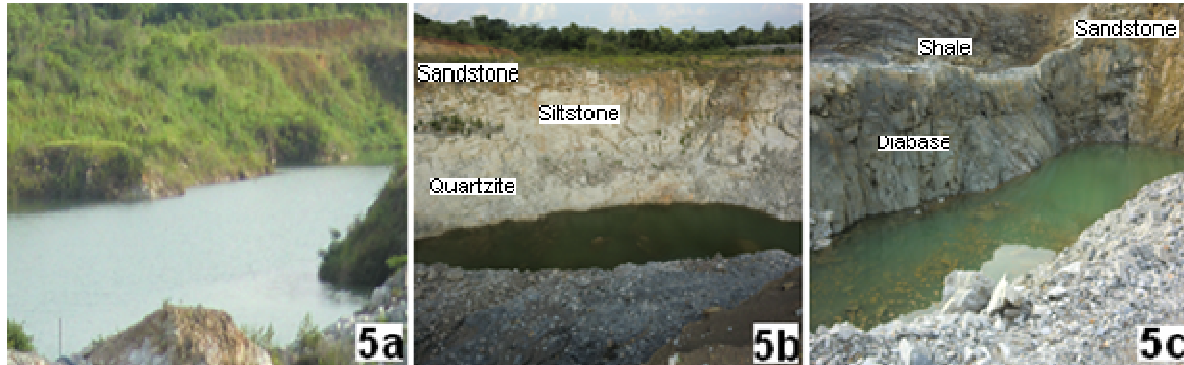
Figure 5: Photograph of abandoned quarry pits in the area, with physically observed rock units corresponding to the electrical resistivity result

Figure 5, **a**: A very deep, poorly planned quarry pit completed and abandoned. Depth estimated to 50 ft, with roughly excavated overburden surface, vegetation, and associated land organisms merged with pit water. Natural environment and ecosystem is in danger. **b**. Evidence of rock over breaking, pit slope (90°), pit is temporary abandoned after selective mining of near surface diabase intrusive boulders. **c**. Pit water continuously seeps downwards following several cleat joints and fractures of varying magnitude. This is due to over breaking associated with uncontrolled blasting and inappropriate use of explosives. Water in pits 5b and 5c are already maintaining the groundwater table of the locality, confirming continuous pollution of groundwater in the area. Joints and fracture planes extend from the blast rock to lower depths, and to the overburden material, making it incompetent when saturated. Vertical drilling of blast holes causes over breaking of pit walls produces vertical and curved-out pit walls that causes unstable pit slope. Rock fall, overburden sliding, accidents to man and other animals, loss of life, loss of farm land, increasing seismicity, loss of natural ecosystem, are environmental hazards of abandoned quarry pits.

Poor design of quarry pits as observed in figures 5 results in greater hazards including ecosystem destruction. Lack of proper bench heights, working platform, and haulage road makes quarry pit appear more hazardous. Before quarry pits become abandoned, working platforms and inner haulage roads are finally blasted and removed, making most of the abandoned quarry pits in lower Benue trough inaccessible. This increases the geo-hazard potentials of abandoned quarry pits in the area.

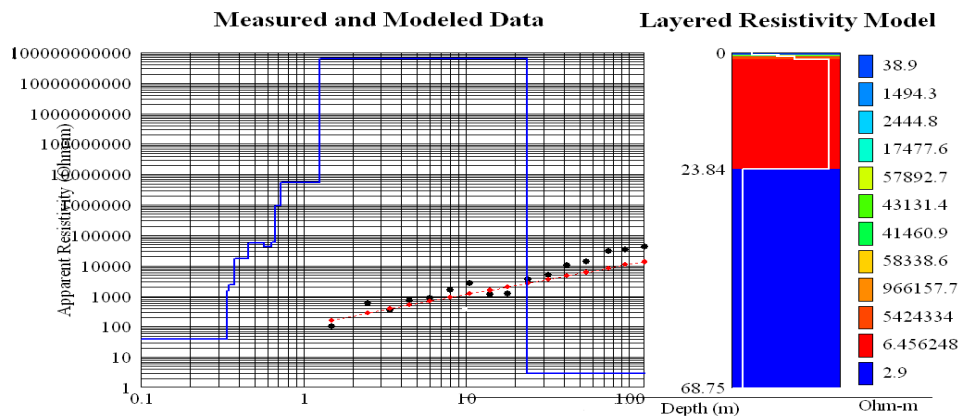
Figure 8: Subsurface inverted model of VES station 2

Table 1: VES 2 TBM 1 – TBM 2 (B); El 339 ft; N05.57.527; E07.29.062

Prospect layer	Thickness (m)	T. Depth (m)	B. Depth (m)	Ohm-m	Rock type	Color
7	0.14	0.26	0.4	58338	Shale	Yellow
8	0.4	0.5	0.9	966157	Siltstone	Brown
9	1.2	0.9	2.1	5424334	Quartzite	Off-Red
10- 11	21.7	2.1	23.8	6456248	Diabase	Red

Figures 8-12 are selected VES models out of a total of eighteen VES conducted in this study, and figures 13-15 are selected resistivity profiles. The models interpretation (Tables 1-5) emphasize on geo-electric responses over diabase (brilliant red), quartzite (off-red), baked clay-siltstone (brown), and shale (yellow). Clay and clay-shale have shades of blue, while sand and sandstone have orange, and green respectively. The yellow color of shale may vary slightly, depends on hardness and indurations, as a function of water saturation. Resistivity values decrease with water saturation, thereby affecting color codes. As a result, the usual order of resistivity: siltstone > shale > clay-shale. The brilliant red color or bright spot is the target rock (diabase). Its prospect at any VES station depends on the depth of occurrence from surface and the respective thickness. The shallower the depth of occurrence, the greater is the prospect and economic benefit of mining the rock to produce aggregates for building and other engineering structures. This is because shallower depth implies less overburden thickness, which accounts for low stripping ratio and overburden stripping cost.

Tables 1-5 show analysis of the VES result at the selected VES stations. T. Depth or top depth is the depth from surface to the top of intrusive body, and B. Depth is the bottom depth of respective rock body. Geo-electric response by apparent resistivity value is in the order of diabase > quartzite > baked siltstone > sandstone > shale. There is no specific order of occurrence of the associated rocks. Usually, quartzite is observed as overlying the diabase. The clay-siltstone is found usually baked, overlying the quartzite, or below the intrusive body. Occurrence of quartzite directly over the intrusive diabase and the baked clay-siltstone can be described as a result of the high temperature contact metamorphism of the Santonian orogenic episode. Economic depth of diabase in the area ranges from 2-11 m (6.5-36 ft) confirming decrease of quarry prospect with increasing overburden stripping ratio.

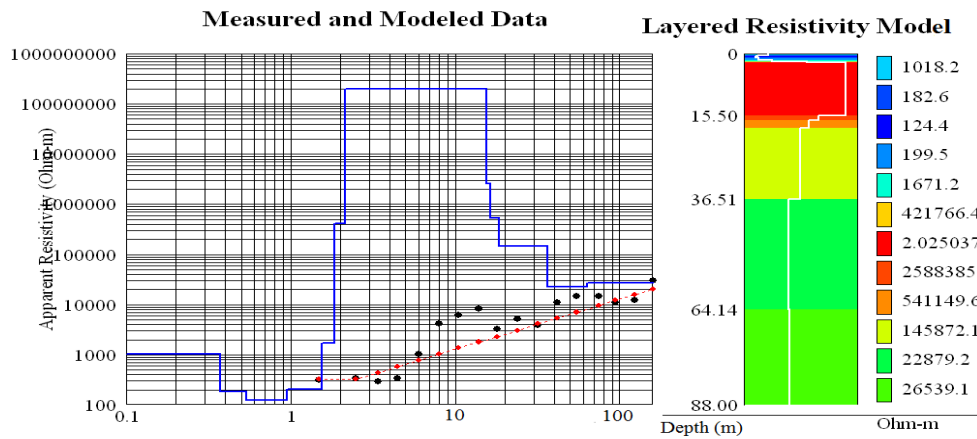
Figure 9: Subsurface inverted model of VES station 3

Table 2: VES 3, TBM 2 – TBM 3 (A); El 324 ft; N05.57.494; E07.29.065

Prospect layer	Thickness (m)	T. Depth (m)	B. Depth (m)	Ohm-m	Rock type	Color
	1.7	11.5	18.5	431766	Siltstone	Brown
7	2.5	13.2	15.5	2025037	Diabase	Red
8	2.0	15.5	17.5	2588385	Diabase	Red
				541149	Quartzite	Off-Red

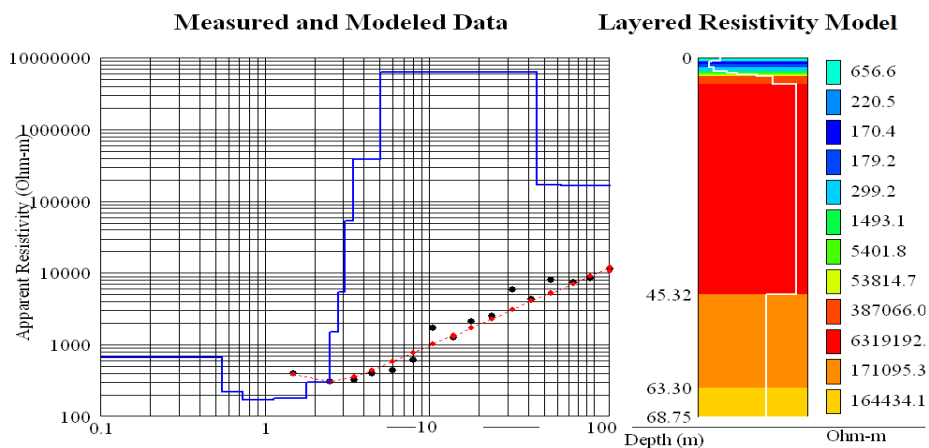
Figure 11: Subsurface inverted model of VES station 12

Table 4: VES 12; TBM 13-TBM 1, El. 319 ft; N05.57.421, E07.29.069

Prospect layer	Thickness (m)	T. Depth (m)	B. Depth (m)	Ohm-m	Rock type	Color
9	2.0	3.32	5.32	387066	Quartzite	Off-Red
10	40	5.32	45.32	6319192	Diabase	Red
11	20	45	63.3	171095	Siltstone	Brown
12	>4.5	63.3	>68	164434	Shale	Yellow

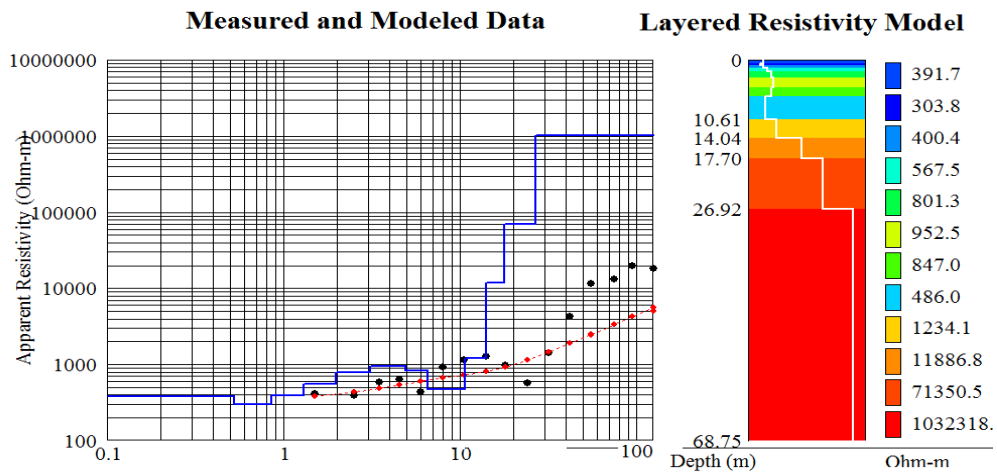
Figure 12: Subsurface inverted model of VES station 2

Table 5: VES 14 TBM 20-TBM 22; El. 299 ft; N05.57.42, E07.29.031 Offset to TBM 14

Prospect layer	Thickness (m)	T. Depth (m)	B. Depth (m)	Ohm-m	Rock type	Color
	3.4	10.6	14.0	1234	Shale	Yellow
9	3.7	14.0	17.7	11886	Siltstone	Brown
10	9.4	17.7	26.9	71350	Quartzite	Off-Red
11	>41	27	> 68.7	1032318	Diabase	Red

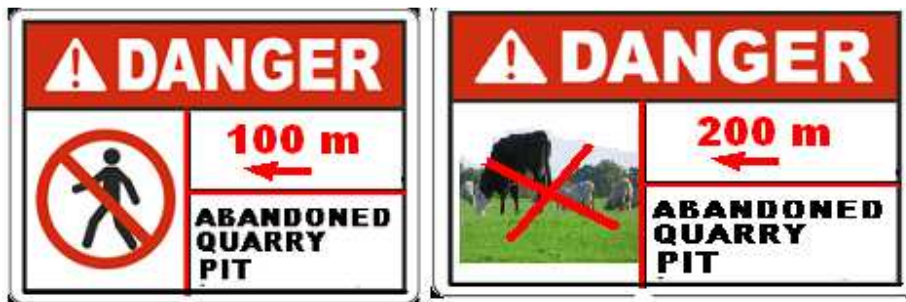
Figure 19: Samples of warning signs for abandoned quarry pits areas Explanation (a) Danger; Movement Restricted, abandoned quarry pit 100 m ahead (b) Danger; Grazing Restricted, abandoned quarry pits 200 m ahead

Warning signs, in form of posters and sign posts should be used in addition to alert the public on the presence and dangers of abandoned pits. Wogalter et al. (2002) stressed the need to enhance the usability of danger or warning sign designs by considering factors internal to the user (e.g., beliefs, perceptions of risk and danger). They also developed an evaluation method that can be used to measure the effectiveness of warnings signs, such as the degree to which warning signs are communicated to recipients and the degree to which they encourage or influence behavioral compliance and safety. Warning signs are to be placed at strategic locations from 500 m, and at regular interval of 100 m to the very location of a quarry pits. This will help to control movement into abandoned pit areas particularly cattle grazing. Figure 19 shows samples of warning signs that may be placed at strategic locations in the vicinity of abandoned quarry pits. Approval of quarry license shall depend on the result of geophysical mapping and economic evaluation of intrusive bodies mapped. This paper calls for solution; collaborative sustainability studies, attention of governments and international agencies for sustainable quarry practice and improvement of environmental quality.
