Influence of Morphological Characteristics on the Sustainability of Underserved Settlements: A Case Study in *Jaffna* Municipality and its Urban Fringe, Sri Lanka

Cavitha Thiliepan ^{1*}, Thennakoon, T.M.S.P.K ², Buddhika Madurapperuma ³

OIDA International Journal of Sustainable Development, Ontario International Development Agency, Canada.

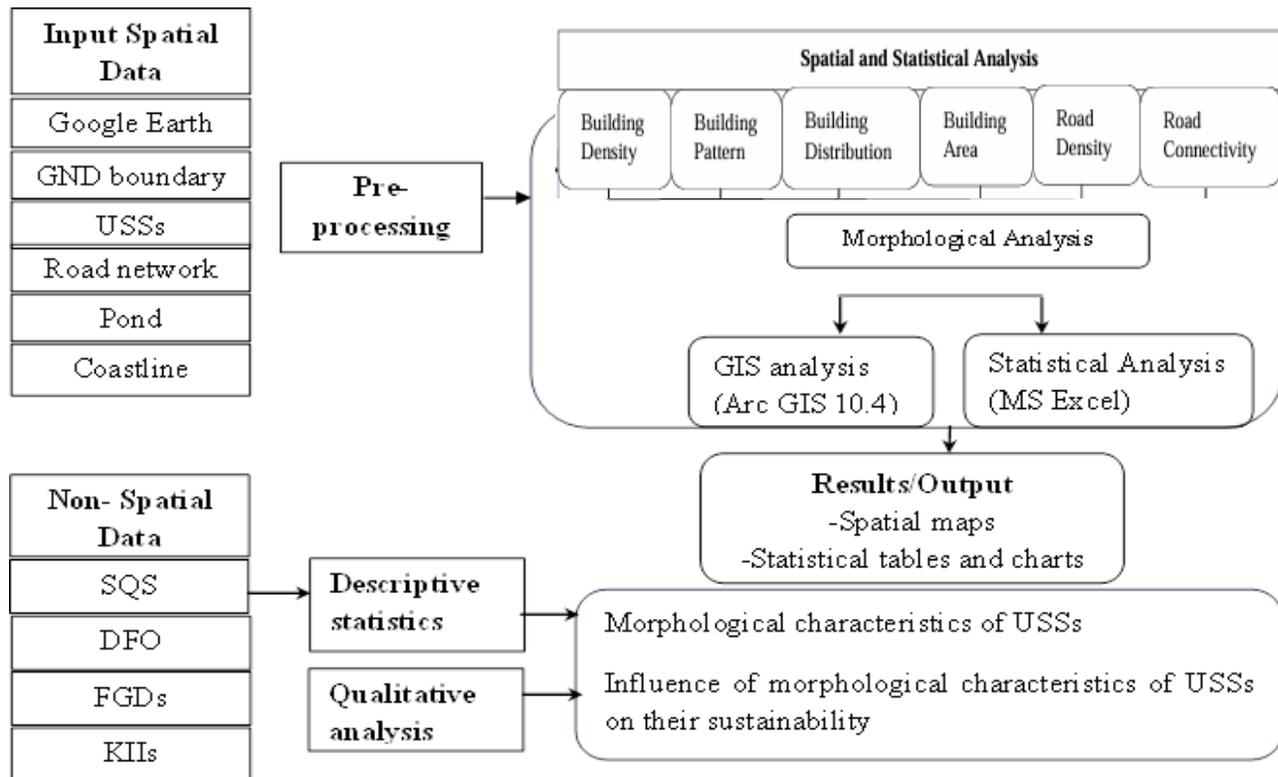
The housing standard of USSs was assessed using descriptive statistics based on data collected from the SQS in terms of the criteria mentioned in the data collection section of 3.4. The extent to which the settlements comply with building regulations was examined using the UDA building regulations. Data on the influencing factors for the design of houses in contravention of building codes and regulations in the study area was gathered through KIIs and qualitatively analyzed. Furthermore, by combining all the data collected in the field, it was qualitatively analyzed how the morphological characteristics of USSs influence their sustainability (Fig. 3).

Fig. 3. -Flow chart of the study's methodological framework.

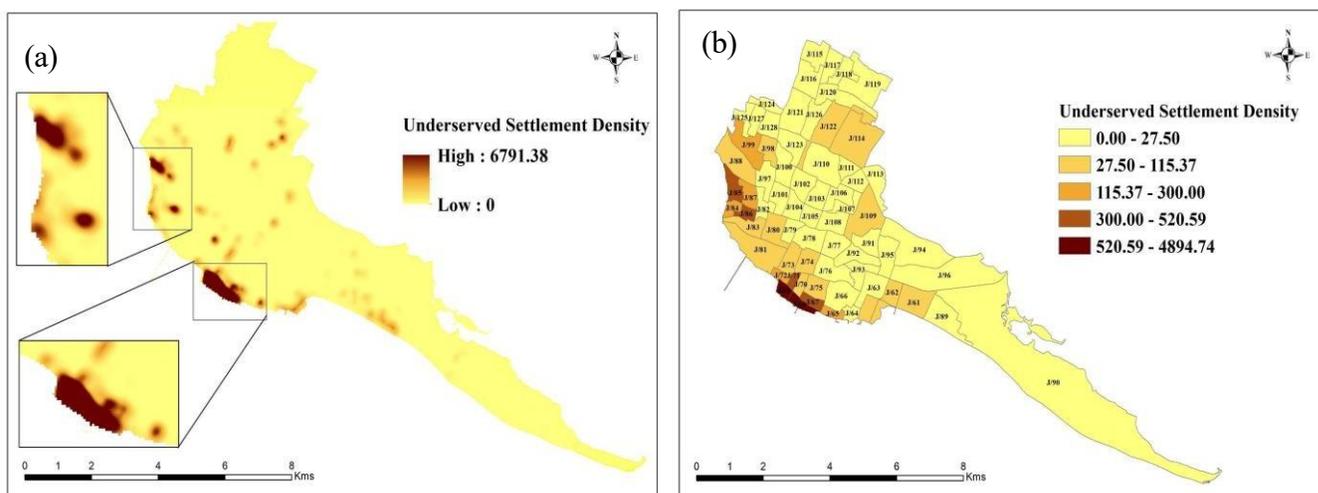
The kernel density estimation results are shown in Fig. 4. According to that, the minimum density is 0, the maximum density is 6791, the mean density is 73, and the standard deviation is 41. The geographical distribution of USSs is most prevalent in the city's coastal belt when compared to inland areas. As shown in Fig. 4a, they are particularly congested as clusters along the western and south-west coasts. Their spatial distribution, on the other hand, is constrained by their proximity to the coast. Subsequently, the USS density was calculated based on GND, and the equation used to calculate the USS density is mentioned in section 3.5. Fig. 4b shows the density of USSs based on GND.

Fig. 4. Density of underserved settlements in the study area: (a) kernel density, (b) the density of USSs based on GND.

The average density of USSs is 107 USS/km². Of the GNDs, *Passaiyoor West, Thirunagar, Reclamation East and West, Gurunagar West, Small Bazar, Jaffna Town East, Navanthurai South and North, Moor Street South and North,*

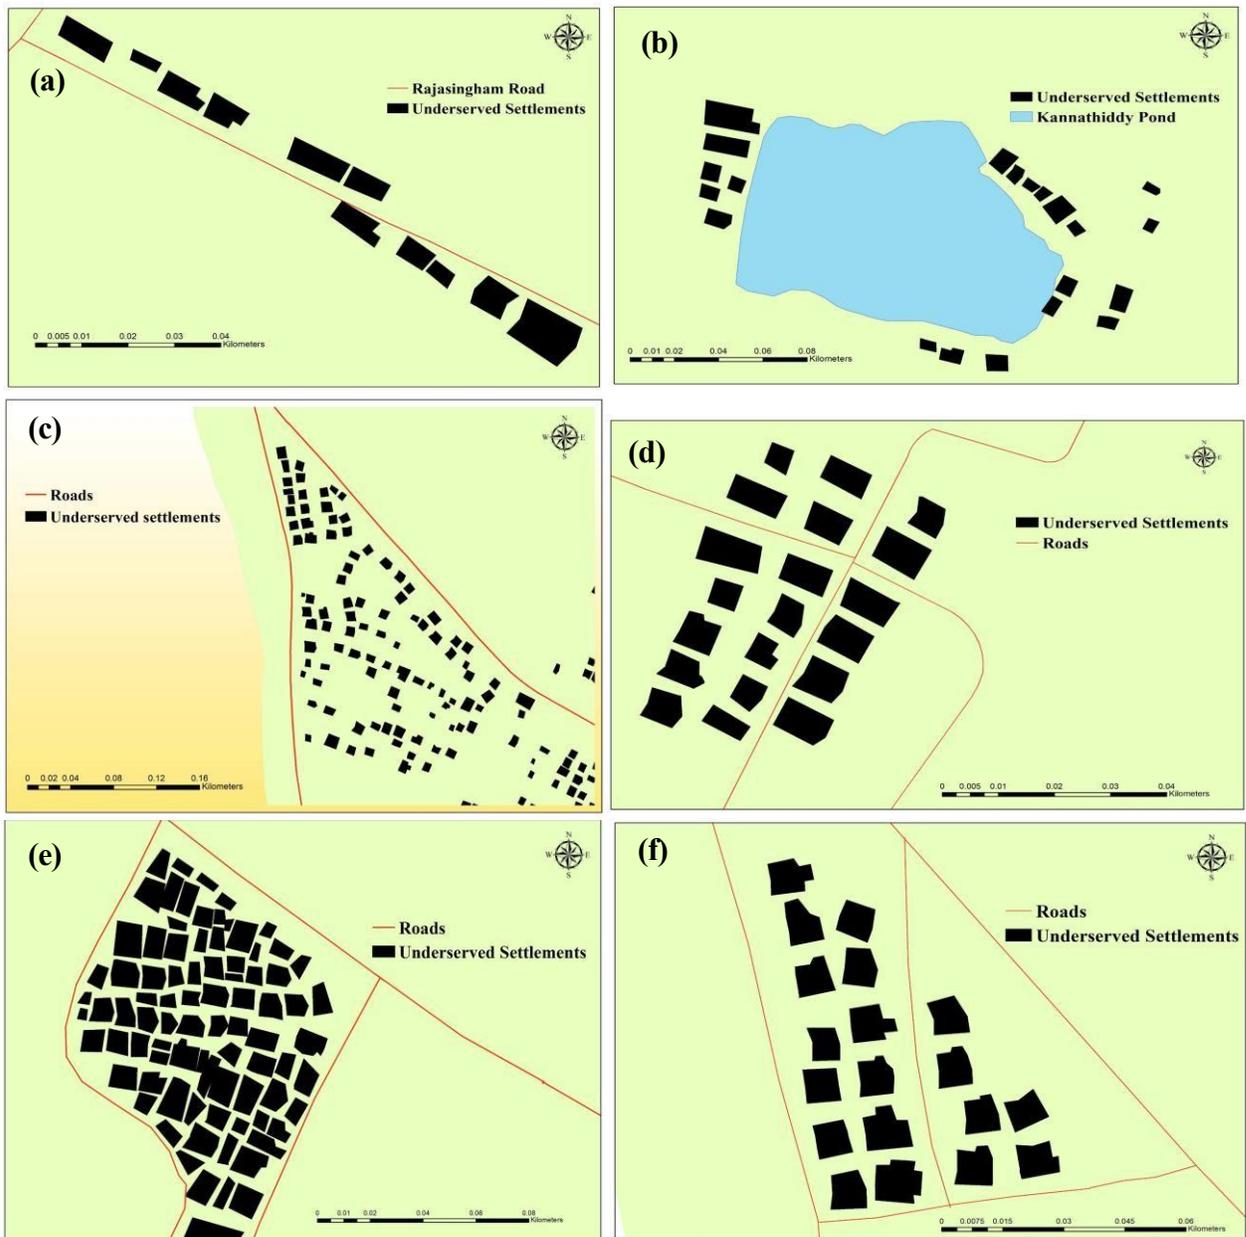
The USSs in the study area have a range of building patterns, namely linear, triangular, rectangular, circular, regular, and irregular. The linear pattern is represented by USSs along roads, railway lines, canals, and coastlines. USSs are found in a linear pattern along the coast from *Nedunkulam* to *Navanthurai North*, on railway lines from *Rasavinhoddam* to *Alupanthy port*, and in front of the University of *Jaffna's* new girls' hostel. Furthermore, linear patterns of USSs can be found along some pathways, such as *Rajasingham Road*, *Beach Road*, *Convent Road*, *Esplanade Road*, and *Cross Roads*. The linear pattern is represented by 2938 USSs, 1005 of which are based on the coastline, 142 on railway lines, and the remainder on roadways. USSs with a triangular pattern have formed in *Navanthurai North*, between the *Navanthurai-Oddumadam Road* and *Jaffna Ponnalai Point Pedro Road*. The pattern is composed of approximately 101 USSs. The semi-circular building pattern is represented by about 23 USSs. These USSs can be found near *Kannathiddy*, *Thevarir*, and *Cheddiyarhoddam ponds*. Furthermore, USSs in *Reclamation East* have encroached on the prawn cultivation site and built around a portion of the lagoon site. Rectangular patterns are found where roads intersect perpendicularly. The rectangular layout is represented by nearly 164 USSs. Shapeless buildings are constructed for human comfort without any planning, resulting in an irregular pattern in the study area. In this pattern, roads grow out of the gabs of structures, while buildings grow out of the gabs of space. These types of USSs are found all around the study area. Concurrently, USSs with regular patterns were established at *Vasanthapuram* of *Nedunkulam* and *Navanthurai North*, *Tharakulam* and *Gurunagar's Flats sites*, and the *Ponnamapalam sites* of *Passaiyoor East*. Fig. 5 depicts linear (a), semi-circular (b), triangular (c), rectangular (d), shapeless (e) and regular (f) building patterns of USSs in the study area.

Fig. 5. Building pattern of underserved settlements in the study area: linear (a), semi-circular (b), triangular (c), rectangular (d), shapeless (e) and regular (f).

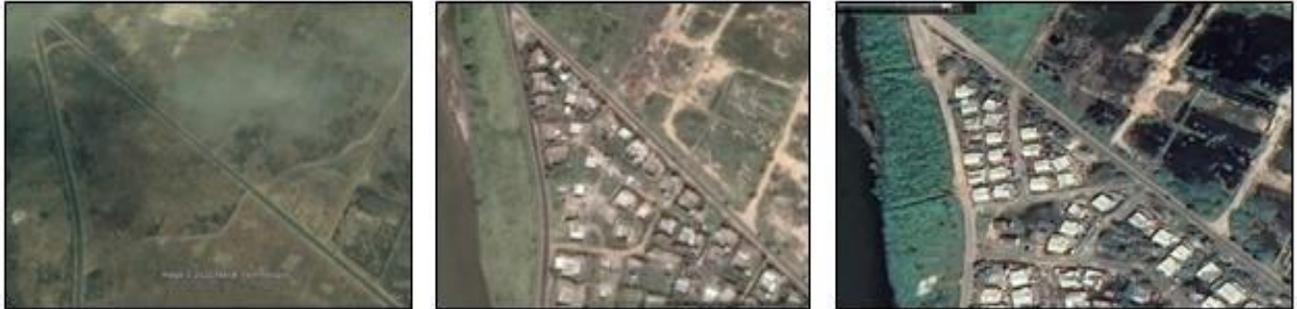
According to UDA administrative officers, settlements in *Reclamation East* and *West* followed a regular pattern when they were established. However, due to the concentration of the population in a limited space, settlements became congested, resulting in an irregular building pattern. In contrast, *Vasanthapuram* settlements had irregular building patterns until 2020, but now the land has been regularized and the settlements have been built in a regular pattern. Fig. 6 depicts the transformation of the *Vasanthapuram* settlement's building pattern in 2002, 2015, and 2021, respectively.

Fig. 6. Transformation of building pattern of the Vasanthapuram settlement.

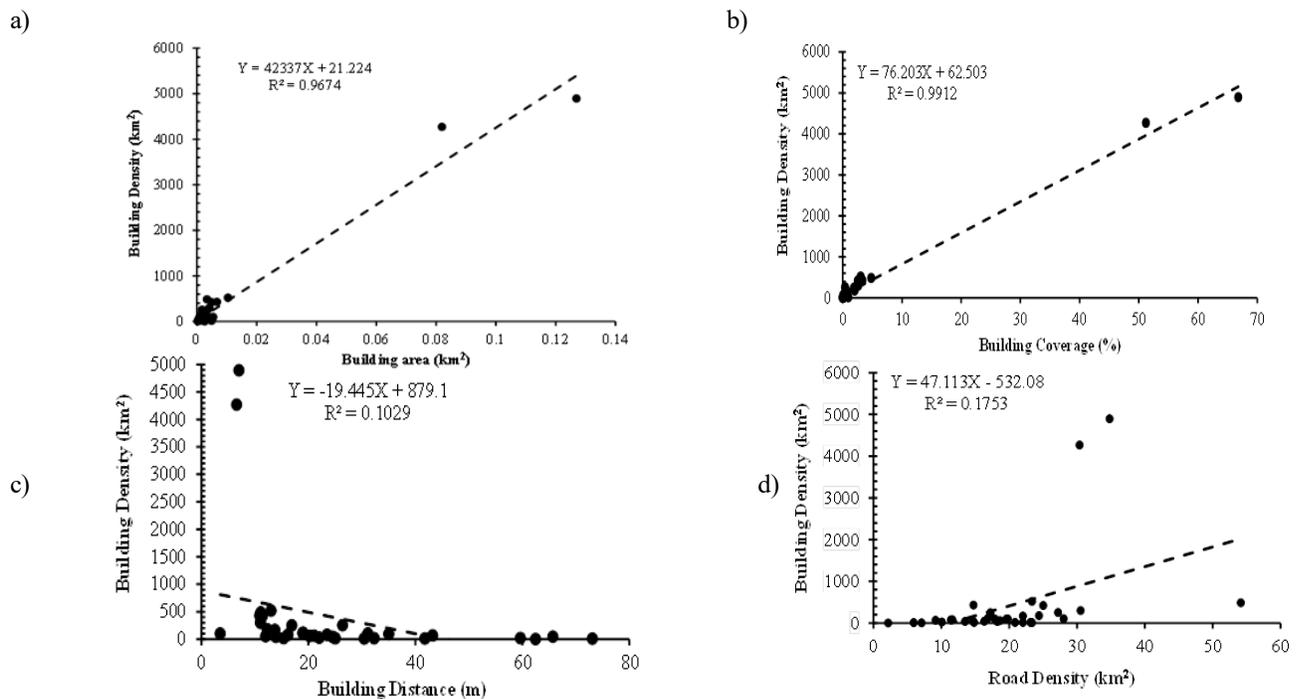
The relationship between the independent variables of building area, building coverage, building distance (Euclidean distance), road density and the dependent variable of building density is shown in Fig. 7.

Fig. 7. Relationship between morphological characteristics of underserved settlements.

As seen in Fig. 7, the building area and coverage have a strong positive correlation with building density. Building density increases along with building area and coverage. *Reclamation East* and *West* divisions have the largest building areas and coverage. Simultaneously, building density is also the highest in the divisions. Building distance has a weak negative relationship with building density. Building density tends to decrease with the increase in building distance. The study found that the average building distance between buildings is 13 m. The Reclamation East and West account for 7 m, for the lowest building distance. Many buildings are very close together in this area and have a disordered orientation, and the typical distance between buildings in these divisions gradually shrinks over time. Road density has a moderate positive correlation with building density. Building density tends to increase with the increase in road network density. Convenient transportation can promote economic development within settlements. In the study area, economic activity is concentrated along the main roadways, and the underserved buildings are also concentrated along these roadways. In many circumstances, buildings are typically built in the USSs first, and then roads are built around them. Building coverage accounts for 99% of the variation in building density, whereas building area accounts for 97% of the variation; building distance accounts for 10% of the variation, and road density accounts for 18%.

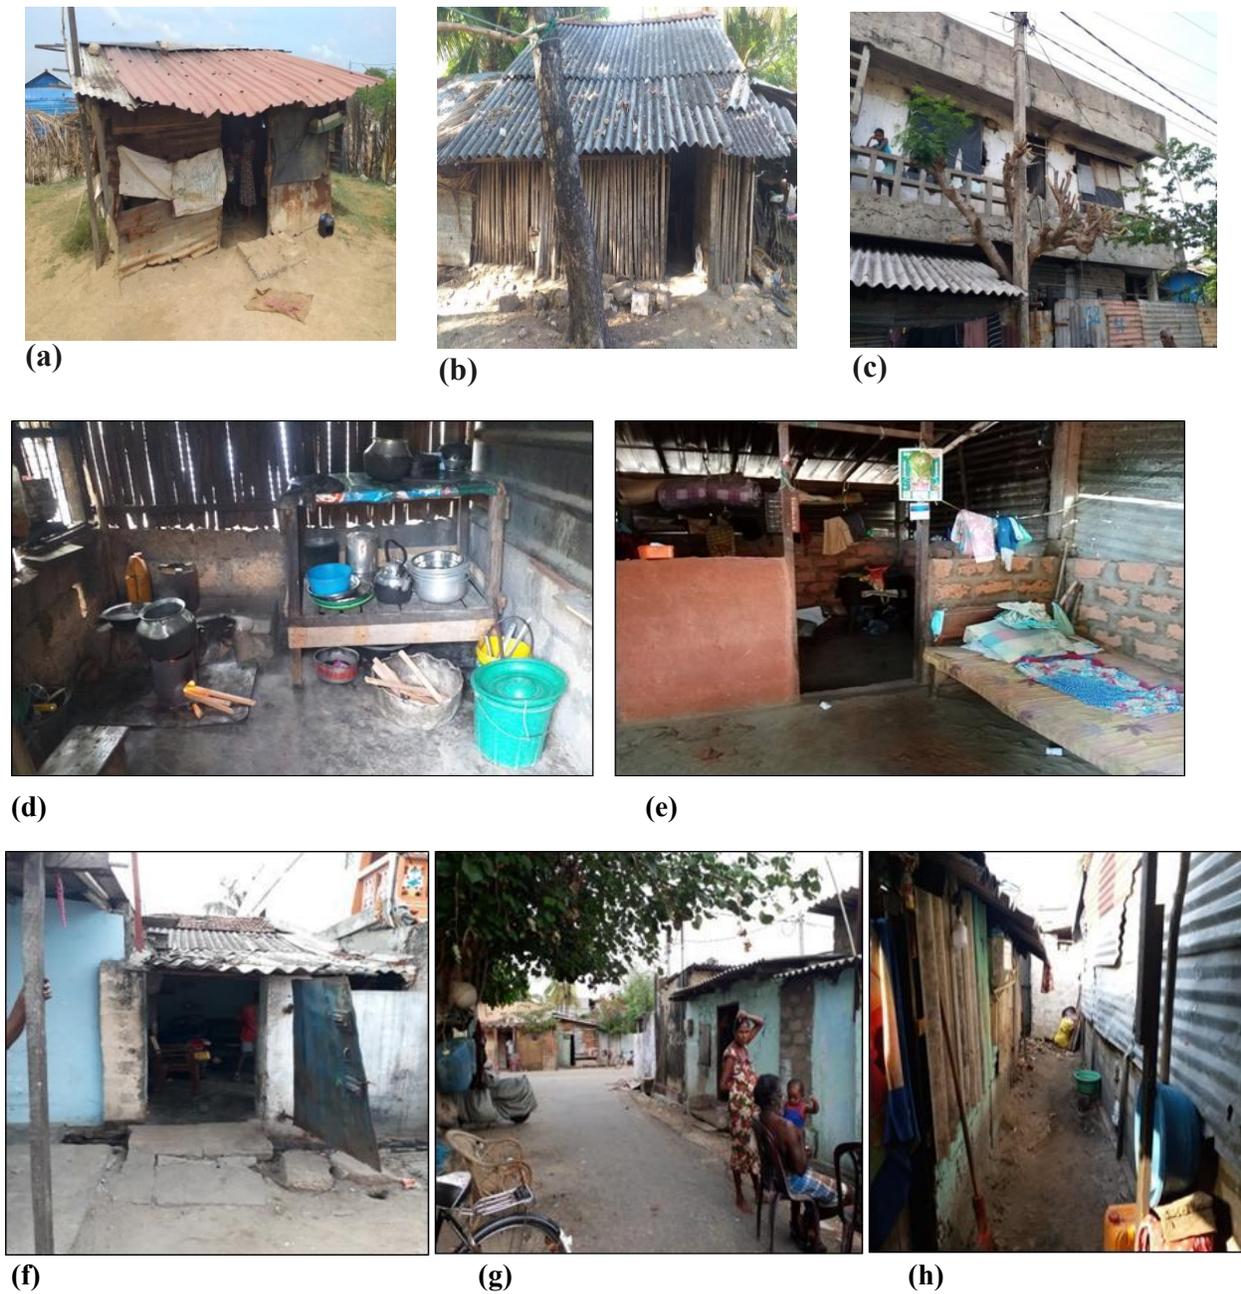
In the study area, 16% of USSs are temporary, 13% are semi-permanent, and 71% are permanent. 94% of permanent USSs are single level, with the remainder having one or more floors. In the study area, 4% of USSs have no rooms or partitioned space, 37% have a single room, 39% have two rooms, and the remaining USSs have more than two rooms. Bedrooms are available in 96% of the USSs. Furthermore, 37% have an inside kitchen, 24% have an outside kitchen, and 39% do not have a separate kitchen and have designated a portion of their living room for cooking needs. Furthermore, 76% of USSs have either inside or outside toilet facilities, while the remaining USSs share toilets with their neighbours or use common toilets due to the lack of individual toilets. Fig. 8 depicts the housing structures and room layout of the USSs in the study area.

Fig. 8. Housing structures of underserved settlements (a,b,c), and room structure of underserved settlements (d, e) and front, side, and rear spaces (f,g,h).

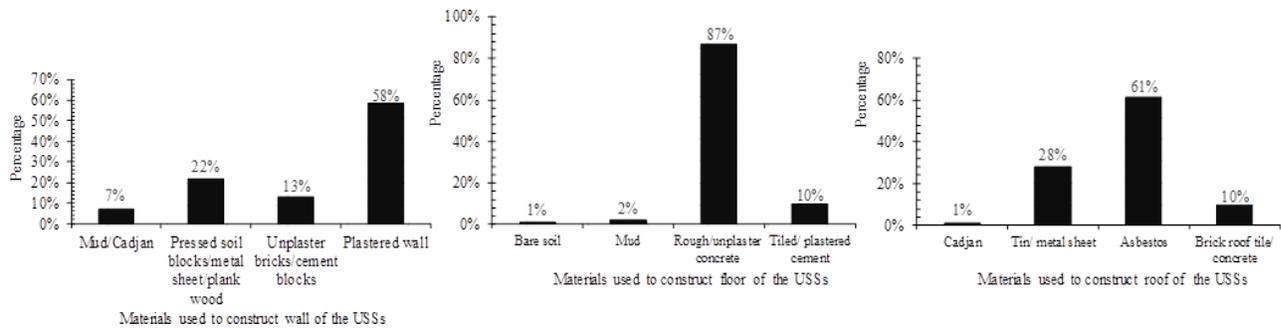
Based on the materials used to construct the settlement walls, 7% are made of mud/cadjan, 22% are made of pressed soil blocks/metal sheet/planks, 13% are made of unplastered bricks/cement blocks, and the rest are plastered walls. According to the floor materials, bare soil is used in 1% of the USSs, mud is used in 2%, rough concrete/cement is used in 87%, and tiled floors are used in the remaining USSs. According to the materials used to build the settlements' roofs, 1% have cadjan roofs, 28% have metal sheet/vinyl sheet roofs, 61% have asbestos, and the rest have brick tile/concrete roofs. Fig. 9 depicts the materials used to construct the USSs' wall, floor and roof respectively.

Fig. 9. Material used to construct the underserved settlements.

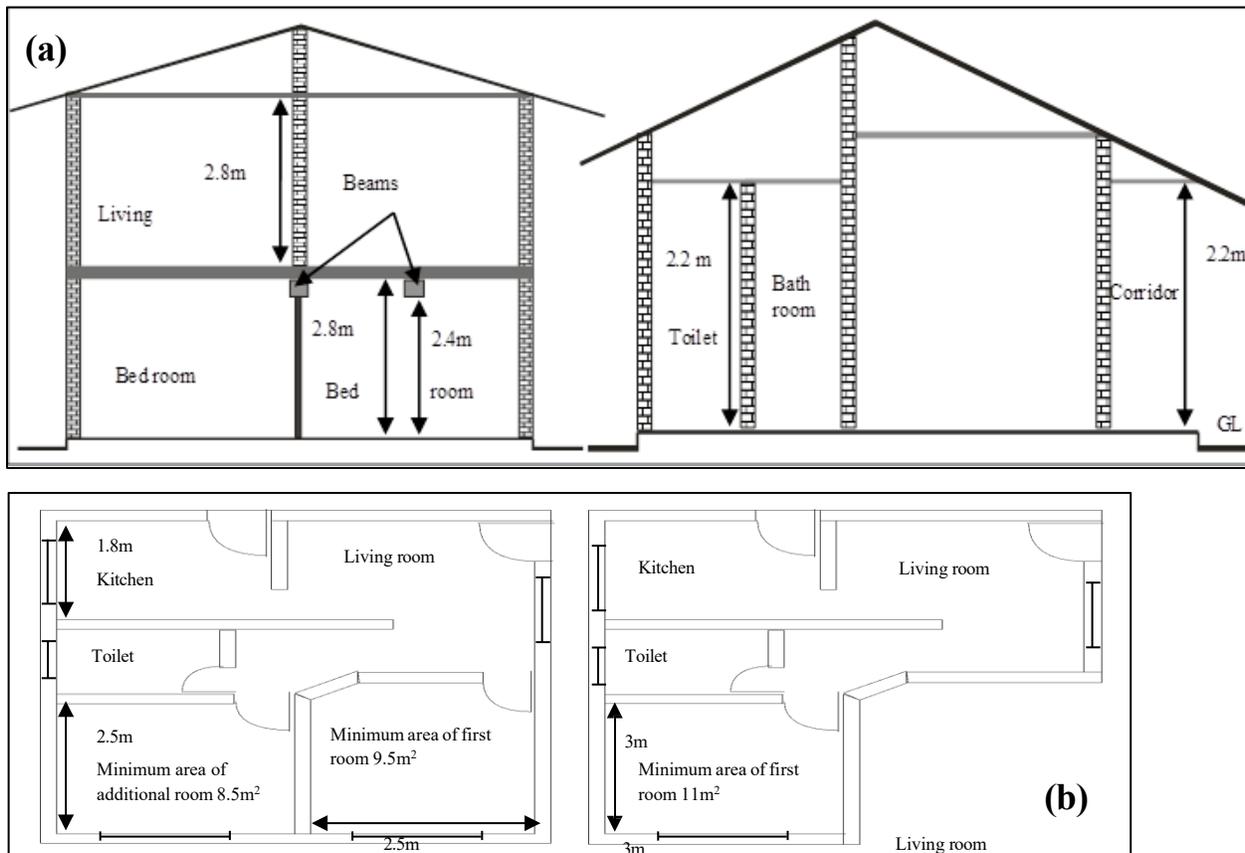
According to UDA building regulations, the internal average heights of the living room, bedroom, and kitchen should not be less than 2.8 m on average, with a minimum of 2.4 m at the lowest point. Furthermore, the toilet, bathroom, and corridor should all have interior heights of at least 2.2 m. Figure 10a shows the standard internal heights of rooms. Based on UDA building regulations, if a housing unit has only one room, the minimum width of the room should be 3.0 m and the minimum area should be 11 m^2 . If a housing unit has more than one room, the first room should have a minimum width of 2.5 m and a minimum area of 9.5 m^2 , while the additional rooms should have a minimum width of 2.5 m and an area of 8.5 m^2 . The kitchen should have a minimum width of 1.8 m and a minimum area of 5.5 m^2 . Furthermore, the minimum width of the bathroom or toilet should be 1 m, and the minimum area should be 1.7 m^2 . If both the toilet and the bathroom are annexed, the minimum width should be 1.5 m and the minimum area should be 2 m^2 . Figure 10b depicts the standard internal dimensions of rooms.

Fig. 10. The standard internal heights of house (a) and dimension of rooms (b).

However, 82% of single-room USSs do not maintain the internal dimensions of the habitable room. The first room's building standards are not met in 85% of multi-room USSs, while the second room's building standards are not met in 94% of USSs. The internal dimensions of the kitchen are not maintained in 86% of USSs. Furthermore, 77% of USSs with toilet facilities overlook the toilet's internal dimensions, while 60% of USSs overlook the bathroom's internal dimensions. 74% of USSs with attached bathrooms and toilets do not take internal dimensions into account. Internal living room heights are not maintained in 29% of USSs in the study area, internal bedroom heights are not maintained in 25% of USSs, and internal kitchen heights are not maintained in 27% of USSs. Furthermore, 29% of USSs fail to maintain corridor height, 20% fail to maintain bathroom height, and 21% fail to maintain toilet height. Internal heights are frequently overlooked in the temporary and semi-permanent USSs in the study area.

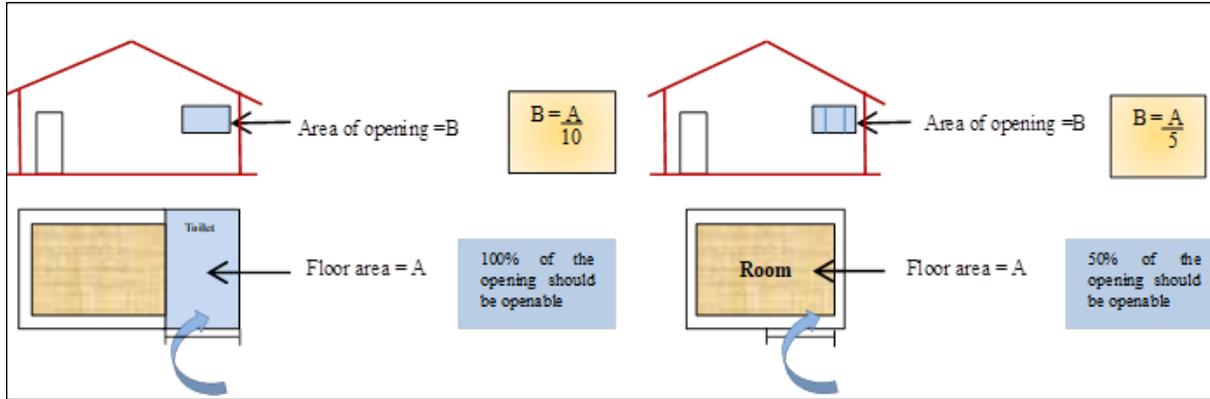
According to the UDA's building regulations, the space for natural ventilation and light in the bathroom and toilet is calculated using the following formula. Simultaneously, UDA insisted that 100% of the openings in the bathroom and toilet be openable. The window area in all other rooms is calculated as follows: Windows and openings shall not be less than one-fifth of the floor area of such a room or space, and at least 50% of such openings or windows shall be openable. The standard window area of rooms, toilets, and bathrooms are depicted in Fig. 11.

Fig. 11.- The standard window area of rooms, toilet, and bathroom.

9% of the USSs in the study area lack windows. 53% of USSs do not maintain the window area of their rooms, and 64% do not maintain the window area of their bathrooms and toilets. A lack of adequate ventilation and lighting was reported by 84% of respondents. Because of their highly congested layout and faculty arrangements, 66% of the USSs do not receive enough natural ventilation and light, particularly in *Passaiyoor East and West, Reclamation East and West, Gurunagar East and West, Small Bazaar, and Navanthurai South*.

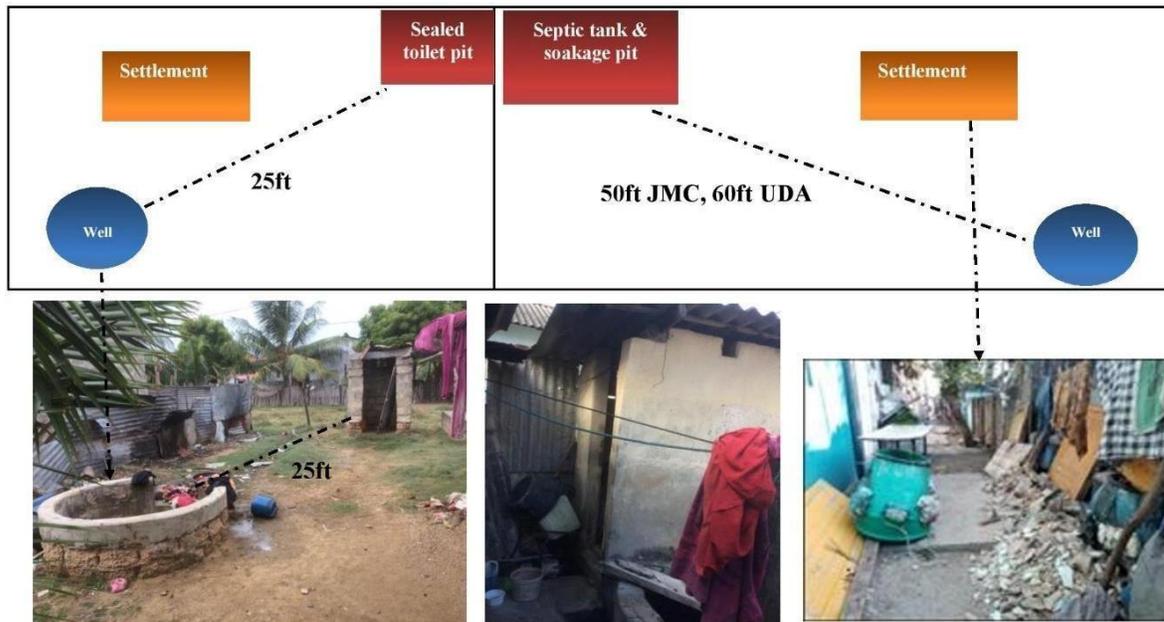
Sealed pits were found in 83% of the USSs in the study area, while non-sealed pits were found in the remaining USSs. According to JMC requirements, if the toilet has a sealed pit, there must be at least 25 feet [ft] between the toilet pit and the well; if the toilet has a septic tank and soakage pit, there must be at least 50 ft between the toilet pit and the well. Conversely, the UDA insisted on a 60 ft distance between the toilet pit and the well if the toilet has a septic tank and soakage pit. Fig. 12 depicts the standard distance between the toilet pit and the well.

Fig. 12. The Standard Distance between toilet pit and well.

However, in the research area, 83% of USSs with sealed toilet pits and 3% of settlements with non-sealed toilet pits do not maintain the distance between the latrine pit and the well. Especially, USSs in *Passaiyoor East and West*, *Reclamation East and West*, *Gurunagar East and West*, *Small Bazaar*, and *Navanthurai South* do not meet the aforementioned standards, with less than 7.62 m between the sealed toilet pit and the well. During the DFO, the toilet pits of the USSs in the aforementioned divisions were found on the road, inside the house, and in the sea.

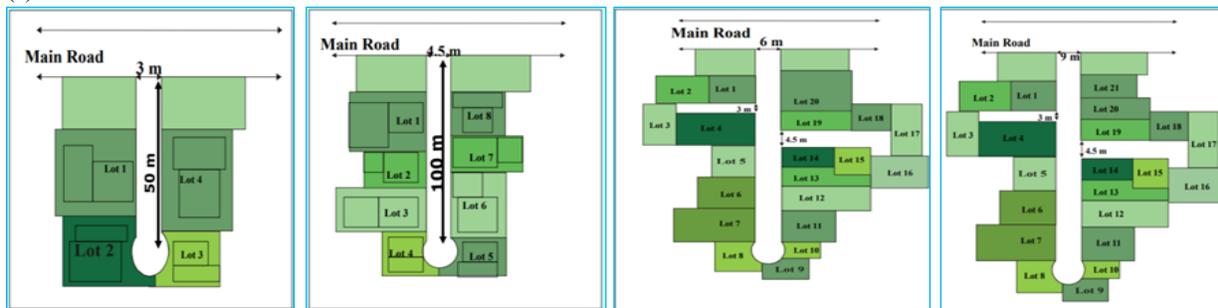
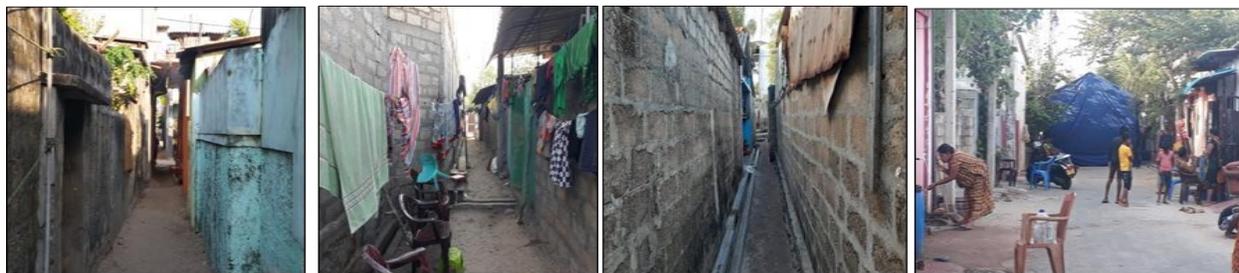
4.5 m wide and 100 m or less in length road serves maximum of 8 lots; 6 m wide road serves maximum of 20 lots; and 9 m or more wide road serves more than 20 lots. Even though accessibility is lacking in 52% of USSs, it is especially lacking in *Passaiyoor East and West*, *Reclamation East and West*, *Gurunagar East and West*, *Small Bazaar*, and *Navanthurai South*. During the DFO, it was observed that the USSs had encroached on the roads, narrowing them and making the areas inaccessible. Figure 13a depicts standard settlement accessibility, while Figure 13b depicts underserved area accessibility.

Fig. 13. Standard settlement accessibility & accessibility in underserved areas.
