THE IMPACT OF THE DAMODAR VALLEY PROJECT ON THE ENVIRONMENTAL SUSTAINABILITY OF THE LOWER DAMODAR BASIN IN WEST BENGAL, EASTERN INDIA

Abstract: The Damodar Valley Project is the first major Multipurpose River Valley Development Project in Eastern India after the country became independent in 1947 from the British rule of over 200 years. Originating from the Khamarpet Hills (1050 meters above mean sea level) of the Chotonagpur Plateau in Jharkhand state and flowing thereafter over the heavily dissected plateau in the upper valley part in the west; the River Damodar enters the rolling plains of West Bengal in the east and taking a sharp right-angle bend, it ultimately joins the Bhagirathi – Hugli River (Ganga River) which falls into the Bay of Bengal. The Upper Damodar Basin is wide fan-shaped in nature where the up-valley hill slope is very steep in contrast to the Lower Damodar Basin which is very narrow and elongated with gentle topography. Again, the river flows just in opposite direction of rain – bearing south west monsoon wind. So, during the monsoon period, the lower Damodar Basin becomes saturated first with the monsoon water and when the south west monsoon wind reaches the

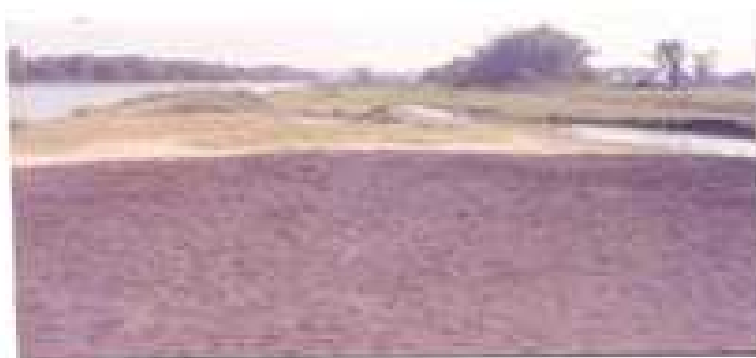
Photo 1: Sandy-clay beds

Due to its typical tropical location, the lower Damodar basin is characterized by the ‘Tropical Monsoon’ climate. Temperature increases during the summer months and this apparent dry pre-monsoon summer receives some occasional smart showers (Nor’ Westers) which help the starting of some earlier crops. Later on, this continuous rise in temperature drops down considerably by 6 degree to 8 degree centigrade with the outburst of the south-west monsoon rain during June and September (annual rainfall ranges between 1200 mm and 1800mm) before it starts to retreat for the year. Since the drainages here are all rain-fed, the seasonal flow variation in the rivers would not be uniform had the monsoon downpour becomes erratic. The winter sets in very gradually from November and lasts for three months with practically no rain for which the rivers of the study area reduce practically into sandy-clay beds (Photo#1).

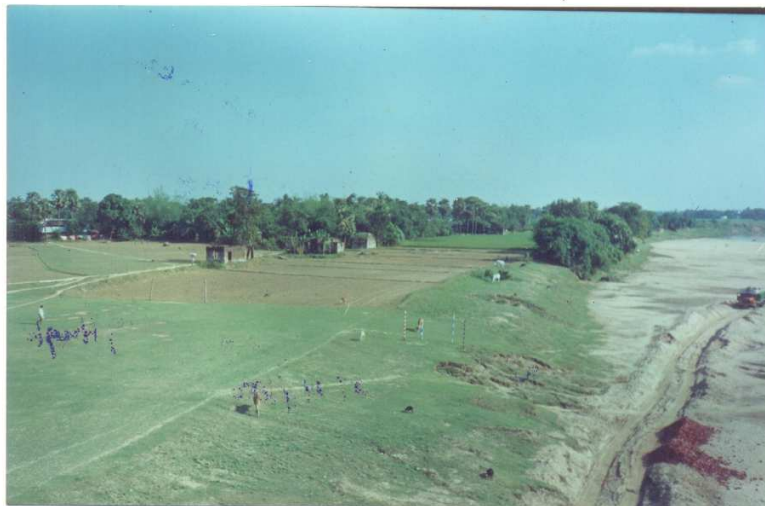
Photo 3: clearly indicates the nature of past flow of the Damodar River i.e. during the Pre - DVC period. It shows the extent of agricultural activities and human settlement on the vast floodplain which is self-explanatory of the load-discharge aspect of the Damodar River in the past.
