# Assessment of Building Collapses in Jos Town, Plateau State Nigeria (2016-2022)

Ketkukah, T.S.<sup>1</sup>, Sule, E.<sup>2</sup>, Mije F.G.<sup>1</sup>, Badamasi, A.<sup>1</sup>

OIDA International Journal of Sustainable Development, Ontario International Development Agency, Canada.

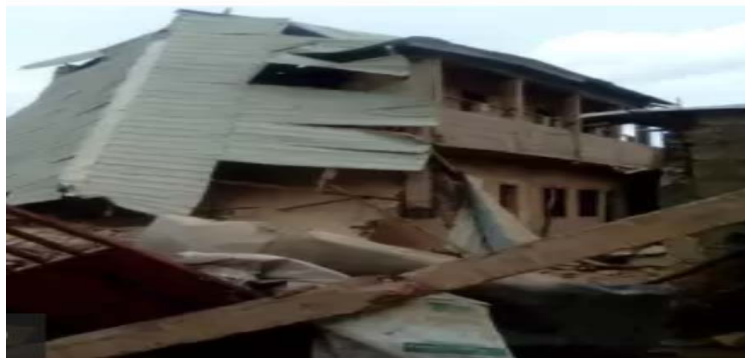
Plate 1: The Partially Collapsed Building (Job, et al, 2016).

The site of the collapsed building was located along Gero Road, Bukuru, Jos South Local Government Area, Plateau State. The building was not approved by Jos Metropolitan Development Board (JMDB). The collapsed building is shown in plate 1.

The building was reported to have collapsed on Sunday 6<sup>th</sup> September, 2015. Six (6) School children died and twelve pupils were injured in the incident according to NBRI Report No. 36 (Job, et al, 2016). The cause of collapse was attributed to the use of quacks, inferior concrete and inadequate amount of steel reinforcement bars. There should be proper bonding between the concrete and the steel and these entail a proper concrete and steel grades/strengths as well as adequate surround of the steel with concrete so that there is good grip. Adequate amount of steel reinforcement should be provided as close to the surface of the element as possible so that an undue cracked section does not have to be permitted in the large concrete area.

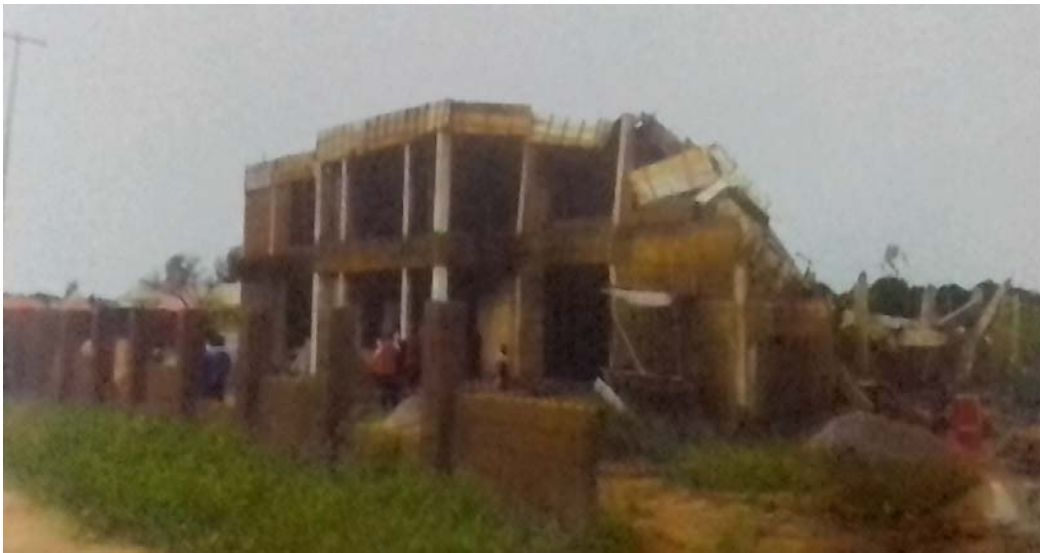
Plate 2: A scene of the Collapse Building Structure (Job, et al, 2019)

The site of the collapsed building is located at Gura-Zot B, Kwang, Jos South Local Government Area, Plateau State. The site lies in the savannah vegetation belt of Northern Nigeria with coordinates of 9.878°N and 8.918°E. The collapsed building is shown in plate 2. No life was lost in the incident but huge properties were lost. Hard earned funds contributed by the Association's members was wasted. It was so pathetic.

The building was reported to have collapsed on Thursday 6<sup>th</sup> September, 2018. The building project had been under construction for about four years before collapse. A registered company was commissioned by NMA to design and build the structure. However, the work later became a direct labour under the supervision of a non-registered Architect. The drawings were not approved by licensed professionals neither was the building approved by Jos Metropolitan Development Board (JMDB). According to NBRRRI Report No. 44 (Job, et al, 2016), the professional that supervised the construction was a non-licensed Builder. He took advantage of ignorant clients to extend his areas of service to carry out the function of other professionals including structural Engineering and architectural services. The required sizes of beams, columns and foundations were provided as specified in structural drawings. The corresponding areas of reinforcement were also not adequate.

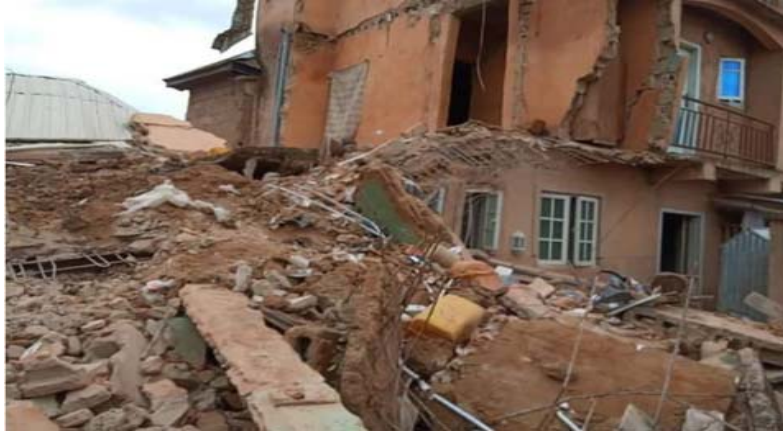
Plate 3: The Building before the collapse (Source: Punch Newspaper, 2019)

The site of the collapsed building is located at Butcher Lane, Pump Street, Dilimi Jos North LGA of Plateau State. The site lies in the savannah vegetation belt of Northern Nigeria with coordinates of 9.922°N and 8.887°E. The building collapsed on Friday 12<sup>th</sup> of July, 2019. The collapsed building is shown in plate 3. The owner of the building with thirteen members of his family lost their life.

The building was constructed in 2012 with batteries of toilets serving public interest at the ground floor and its top being suspended reinforced concrete slab held in place by beams and columns in between sandcrete block walls. The main soak away/septic tank was placed within the building perimeter. The building status was later changed to a storey building with two suspended floors. The construction of the building was prosecuted without relevant construction drawings and competent professional personnel. There was no approval for the building by the Jos Development Board.

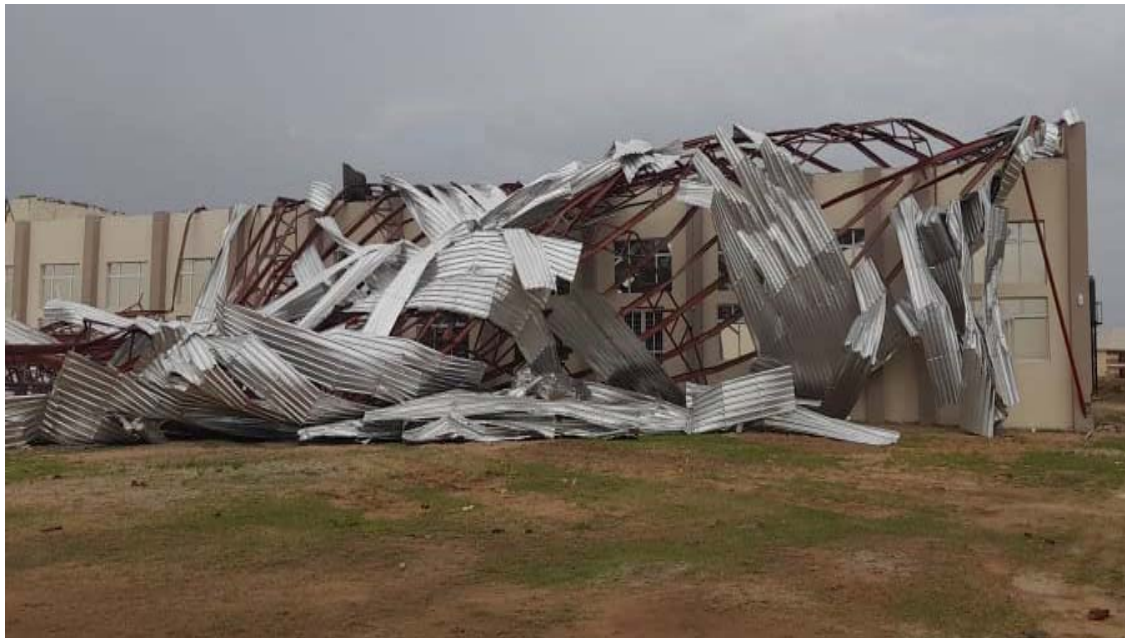
Plate 4: Blown off roof of the Indoor Taekwondo Gymnasium.  
Source: <https://www.unijos.edu.ng/WindstormWreaksHavocinUnijos>

Windstorm wreaked havoc at the Naraguta Campus of the University of Jos on 23rd April, 2022 blowing off the roofs a new Indoor Taekwondo Gymnasium. There was no approval for the building by the Jos Development Board. The failure of the roof was attributed to faulty design and fabrication to resist uplift hence the wind was able to completely remove the roof. Further physical inspection showed evidence of inadequate supervision as seen by non-verticality and undulating shape of the columns. The blown off roof is shown in Plate 4.

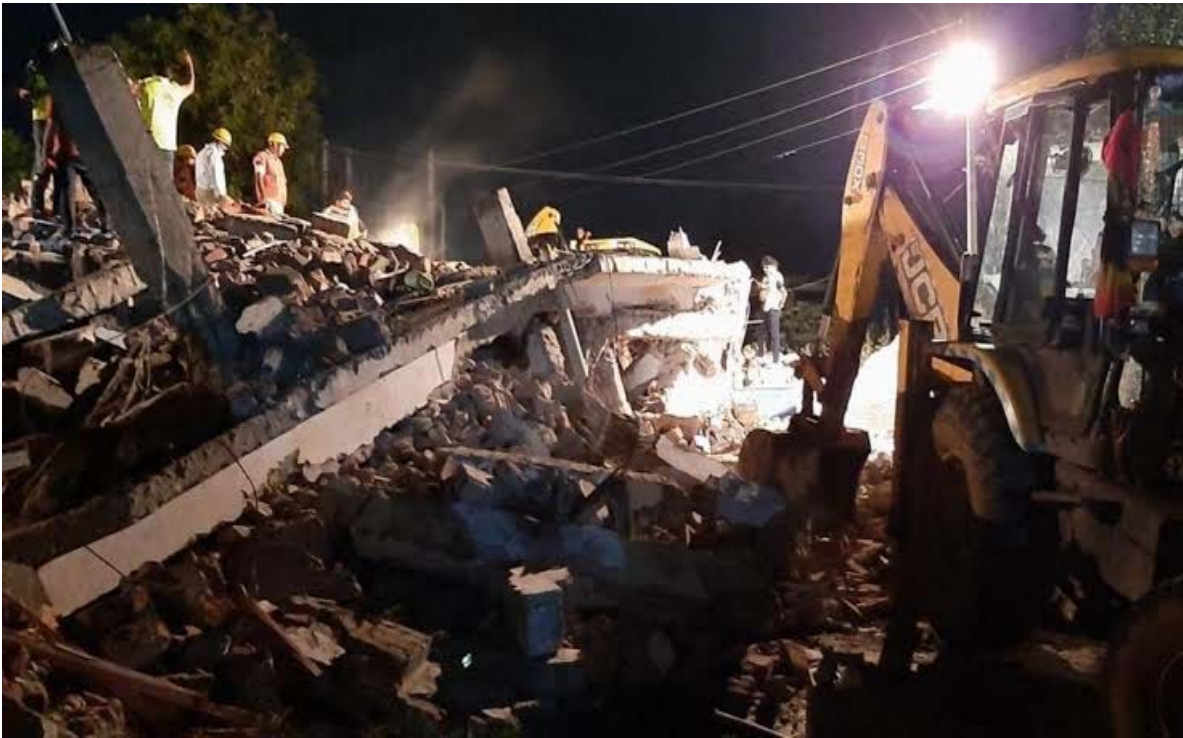
Plate 5: The Building collapse near Bukuru Mini Stadium, Jos South, Plateau State).

The building was located near Bukuru Mini Stadium, Jos South Local Government Area of Plateau State. It had a supermarket on the ground floor with offices upstairs. The collapsed building is shown in Plate 5. No life was lost in the incident but properties were lost including the supermarket properties.

There was no approval for the building by the Jos Development Board also no involvement of qualified professionals in the design and construction of the building (Ketkukah, et al, 2022). The professional that supervised the construction was a non-licensed Architect. He took advantage of ignorant client to extend his of service to carry out the function of other professionals including structural Engineering services. Inadequate sizes of framed elements were used. There

also seems to be a problem of use. The building plan might be initially designed for residential purposes was turned into multipurpose and illegally increased to one storey building without redesign of the building. This was evidence from additional columns introduced during the construction of the upper floor.
